# PROPERTY INSPECTION REPORT

**Main Street Contracting, Inc. DBA  
CR3 American Exteriors**

**123 ABC St  
Inspection Prepared For:  
Sample Roof Inspection  
Agent:**

**Date of Inspection: 8/25/2024  
Weather:**

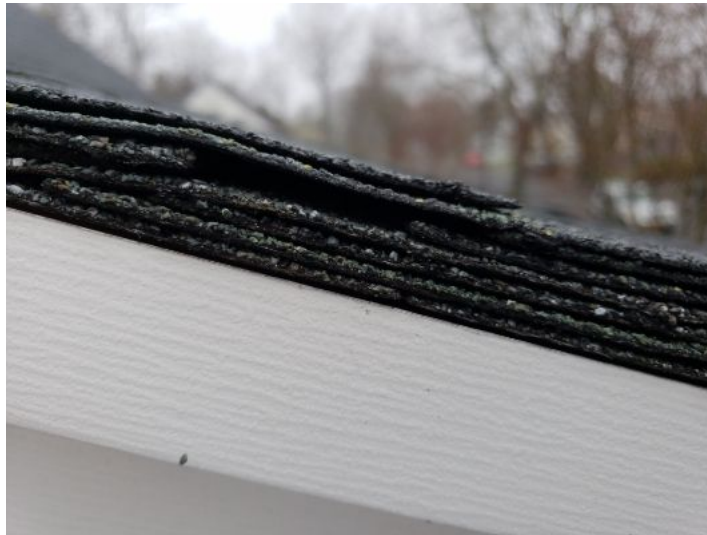
- There are two or more layers of shingles on the roof. Recommend contacting insurance company to verify insurability. One layer is now the maximum allowed.

This condition will result in the following:

- When new roofing is required, both layers will need to be removed before new roofing material can be installed. Whoever owns the home at the time of replacement will be required to pay for removal and disposal of th old shingles, and for materials and installation of the new roof-covering materials. This is much more expensive than simply adding another layer and you may wish to take this into account in your consideration of this property.
- Reduced asphalt shingle service-life of the existing shingle roof compared to similar shingles installed over a proper substrate.
- Any warranty offered for the shingles is now void.
- Shingles will be more easily damaged by hail.

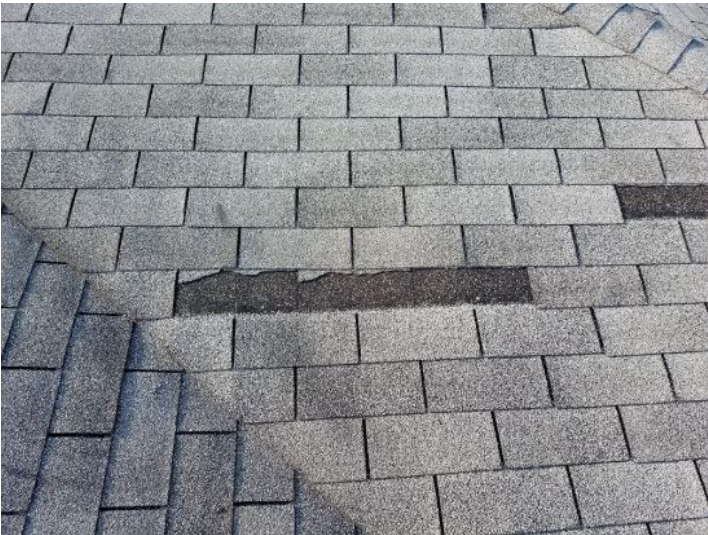
Missing and damaged shingles on roof should be replaced to prevent future damage and water penetration. Holes were noted in the roof near edge recommend this gets reviewed and repaired.

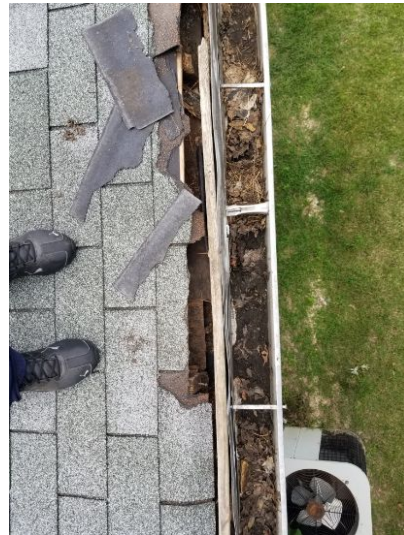
Missing and damaged shingles on roof should be replaced to prevent future damage and water penetration. Holes were noted in the roof near edge recommend this gets reviewed and repaired.

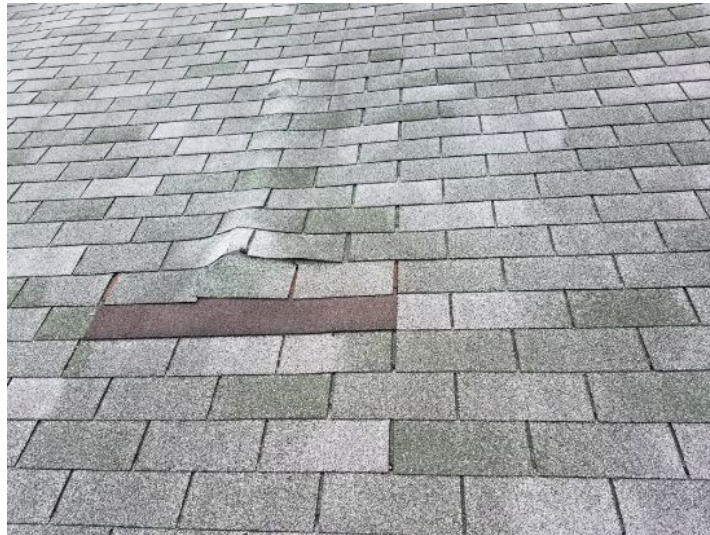
Localized high areas in the roof plane were visible in the roof in various areas of the roof exterior.

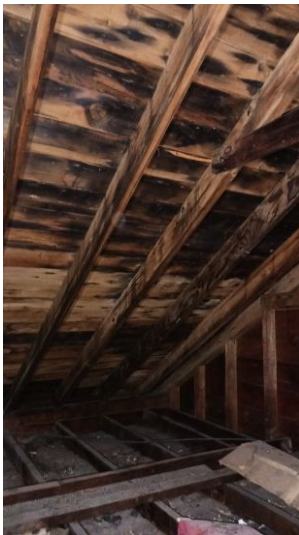
The attic exhibited widespread discoloration that appeared to be microbial growth, possibly mold. Confirming the presence of mold would require laboratory analysis. To avoid potential damage to home materials or the development of unhealthy conditions related to mold, the Inspector recommends that the source of moisture be identified and the condition corrected.

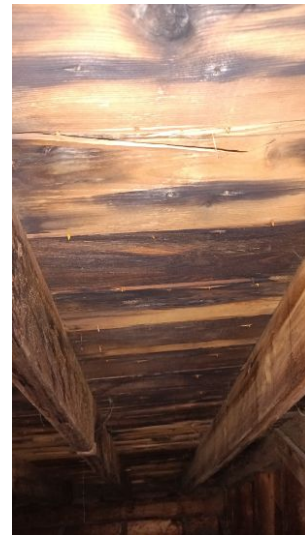
The roof had areas of visible damage to the roof sheathing at the time of the inspection. All damaged areas should be repaired for safety reasons, and to prevent potential damage from moisture intrusion to the home materials, the roof structure and to prevent development of microbial growth such as mold. Before the expiration of your Inspection Objection Deadline, you should consult with a qualified roofing contractor to gain an idea of options and costs for repair.
